THP Limited

St. John's Unitarian Universalist Façade Study

by THP Limited, Inc. • March 2, 2022 • THP 21308.00

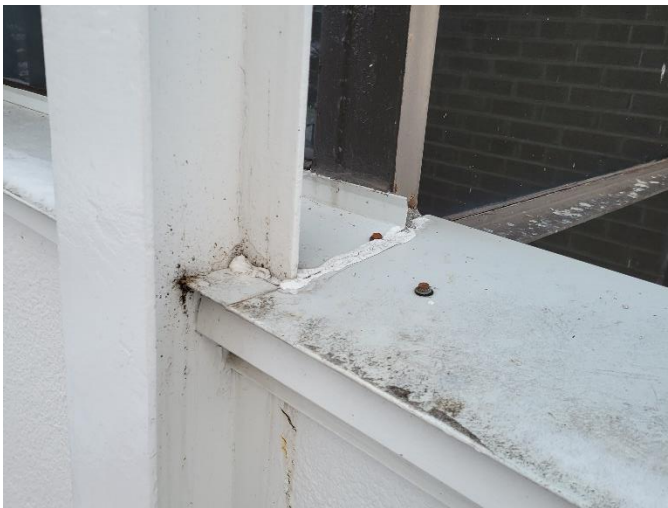
Photo 02

Photo showing bent metal flashing cap over stucco cladding.

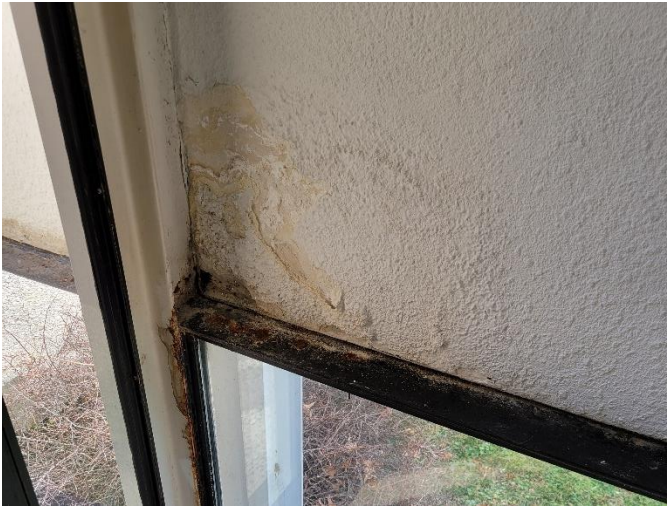
Photo 16

THP observed numerous locations of moisture damage at the interior stucco surface. The most deteriorated areas were located along the lower steel shelf, at the bottom of the stucco wall (Photo 16). At this level, the damage extended intermittently across the full width of the wall, and was concentrated most often around the columns. Deterioration was also noted around the trapezoidal ties (Photo 17). These areas of damage were not as severe as the lower areas. Minimal deterioration of the stucco was seen at the upper reaches of the wall, including where the vertical channels and ties connect the steel at the top of the inner wide flanges. On 1/18/2022, THP and ZSR removed a section of the interior stucco and metal lath to observe the inside of the cladding construction (Photo 18). Though some areas of corrosion were observed, the metal lath was structurally intact (requiring saw cutting to remove). The lathe was wire-tied to light-gauge vertical steel framing members. These members show some surface rust. Inside the wall, paper-backed batt insulation was observed. The paper facer was deteriorated and showed signs of long-term moisture degradation. The lower steel shelf was significantly corroded, along with an attached steel angle (see steel framing section below). Pack rust was visible at the excavation, which correlates to the distress and undulation noted in the steel observations section below.

Deteriorated stucco at inside face of south façade, along the lower steel shelf.

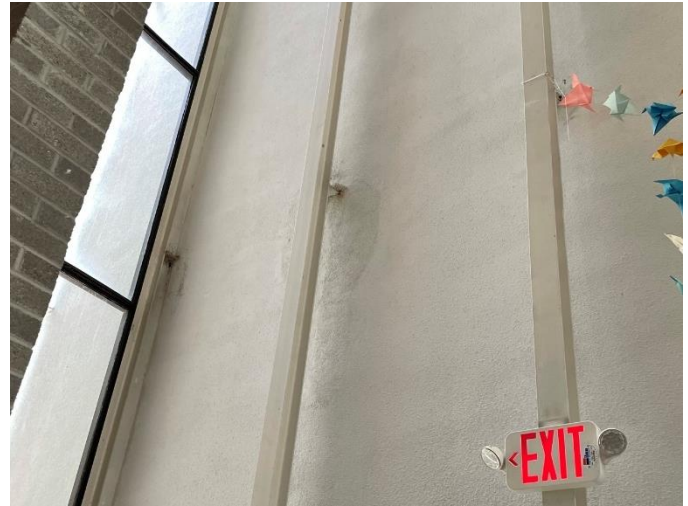
Photo 17

Photo showing deteriorated stucco at the inside face of the south façade, around the trapezoidal steel ties.

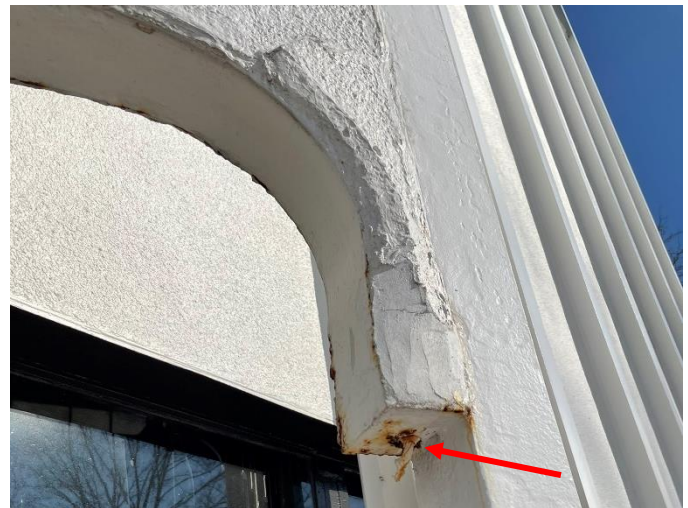
Photo 19

Deteriorated stucco at exterior face of cantilevered, curved cladding section. Note weep rope and hole (red arrow).

At the exterior, THP recommends removal of deteriorated stucco at the tips of the curved, cantilevered sections. Loose and uneven material should be removed, and new stucco applied over the existing lathe (provide new lathe where existing is deteriorated). Where the steel shelf is recommended for replacement (see steel section below), an approximately 12" tall section of stucco will also be required to be replaced along the entire width of the system. After these exterior repairs are complete, deteriorated stucco finish at the interior will need to be repaired. This includes areas of damage along the lower shelf, as well as the areas around the trapezoidal steel ties (see steel section below for repair of the steel itself). Loose material should be removed, and new stucco applied. Once all stucco and steel repairs are complete, both interior and exterior walls should be repainted. This will provide a consistent appearance and provide a warranted system (as compared to individual repair areas).

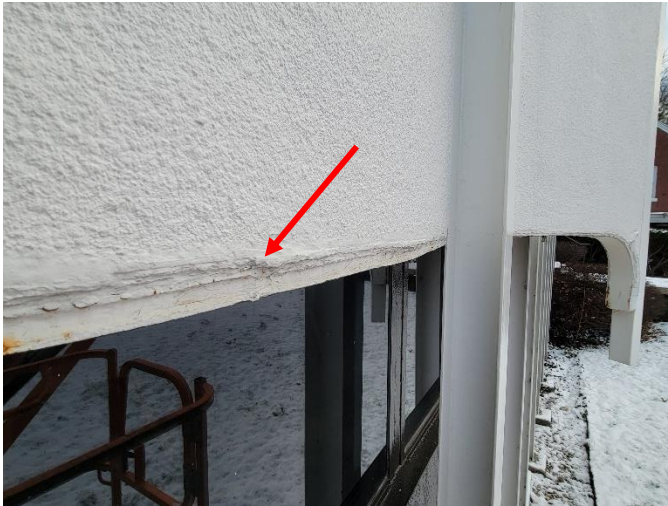
Photo 20

Minor *stucco* deterioration at base of cladding, adjacent to steel shelf plate. (See THP steel observations in section below).

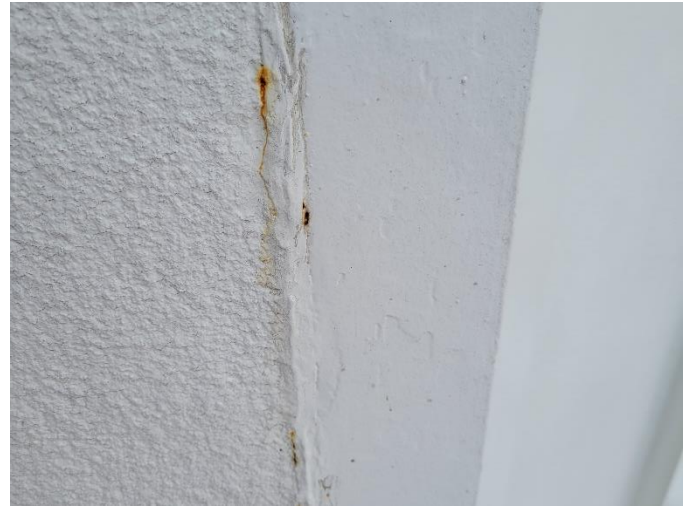
Photo 21

Minor stucco deterioration where stucco meets outer wide flange column.

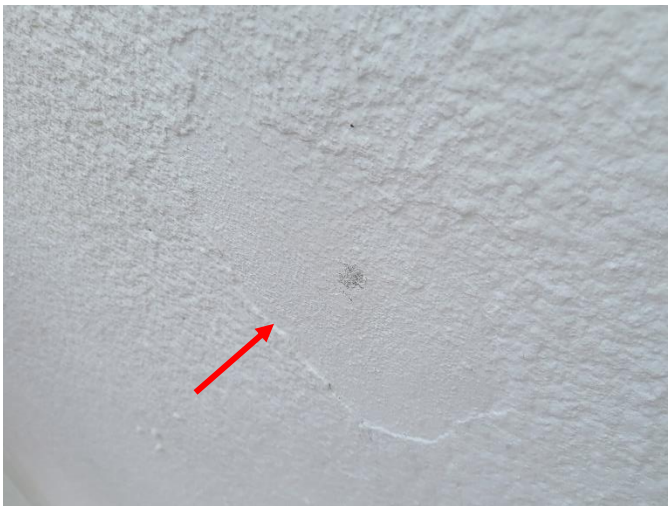
Photo 22

Minor variation in stucco finish, indicating possible past repair.

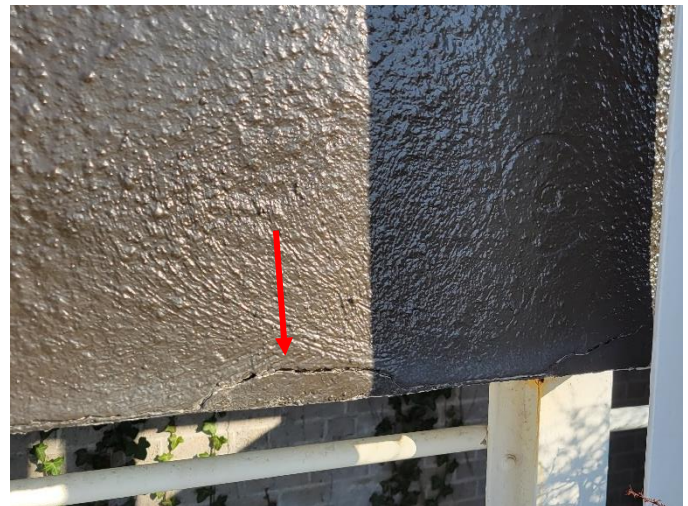
Photo 23

The stucco wall was recently painted, and the sealant joints replaced. THP observed several locations of moisture damage at the exterior stucco, though the majority appeared to be free of distress. Damage was observed at the three curved, cantilevered sections of cladding (Photo 19). At these locations, significant swelling of the stucco was noted, as well as rust staining, and signs of previous repairs. At these locations, the bottom off the wall includes a weep rope and hole, though no such system was called out in the 1959 design drawings. Minor stucco damage was also noted wherever the stucco meets the steel frame – at the lower shelf (Photo 20), the curved steel of the cantilevers, and the outer wide flange verticals (Photo 21). (See THP steel observations in section below for *steel* deterioration at these locations). THP also observed several locations of varying stucco surface, possibly indicating past repairs (Photo 22). At the lower stucco area (below the sanctuary floor), several small locations of cracked stucco were observed (Photo 23).

Minor deterioration at lower stucco cladding and soffit (enclosing floor framing).

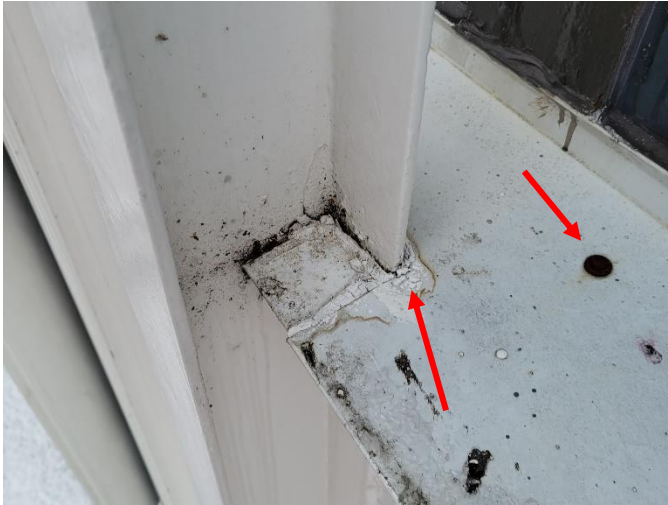
Photo 24

Stiff, disbonded and cracked sealant and deteriorated fastener and gasket at bent metal cap flashing.

THP recommends that the sheet metal flashing of the cap be replaced. After removing the existing flashing and blocking, the steel horizontal shelf should be checked for deterioration, primed and painted. Blocking should be reinstalled/replaced, and new sheet metal flashing installed. The sheet metal should be shaped so as to direct water away from the sides/backs of the wide flange columns. Where the flashing meets the glazing, silicon wet seal can be applied.

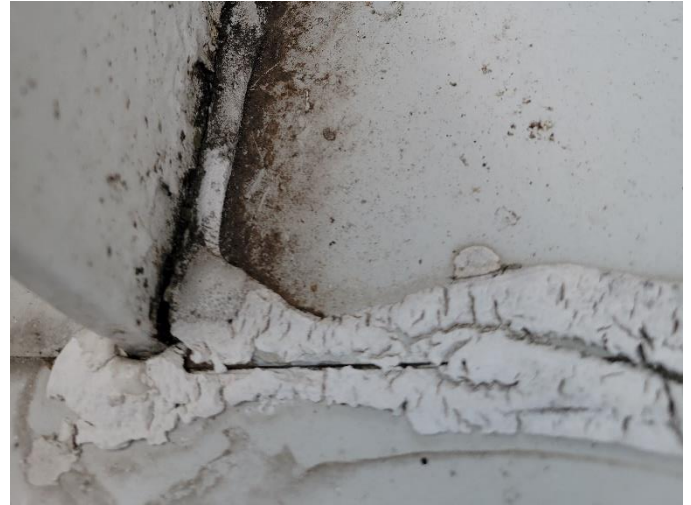
Photo 25

THP observed a variety of deterioration at the metal cap of the stucco system. The gasketed fasteners holding the cap to the wood blocking showed corrosion, and the gaskets were hard and cracked (Photo 24). The cove sealant between the flashing and the wide flange columns did not appear evenly applied. This sealant was hard, disbonded and cracked (Photo 25).

Stiff, disbonded and cracked sealant at bent metal cap flashing.

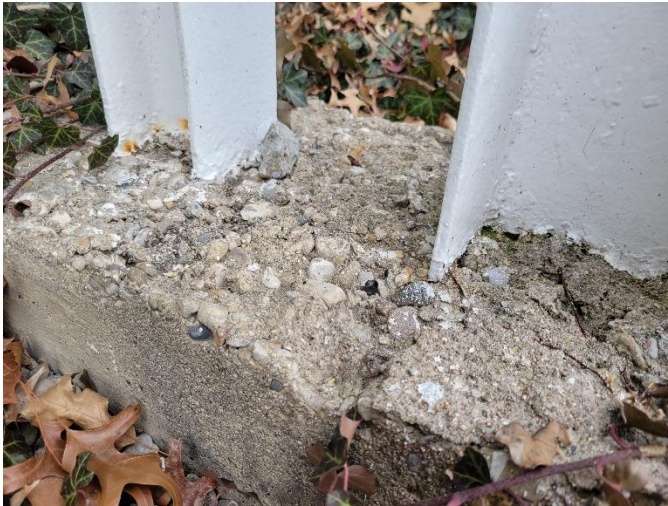
Photo 26

THP observed the paired steel columns from an aerial lift as well as from the ground. At grade, the concrete bearing plate caps appeared pitted, and in some locations were easily chipped with a hammer (Photo 26). Towards the east and west ends of the south façade, dirt and plants have covered the top of the concrete caps. At these locations, the steel columns have significantly rusted and exhibit section loss, due to constant contact with wet material (Photo 27). At other locations, small amounts of corrosion were observed where the steel is embedded in concrete.

Typical column bearing, showing some deterioration of concrete and corrosion of steel.
Photo taken 2/9/2022

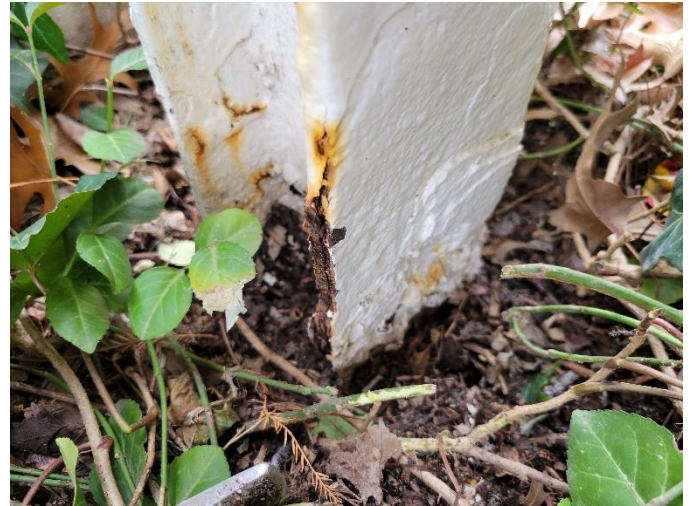
Photo 27

Significant corrosion of steel column exhibiting section loss (typical of columns at either end of south façade).
Photo taken 2/9/2022

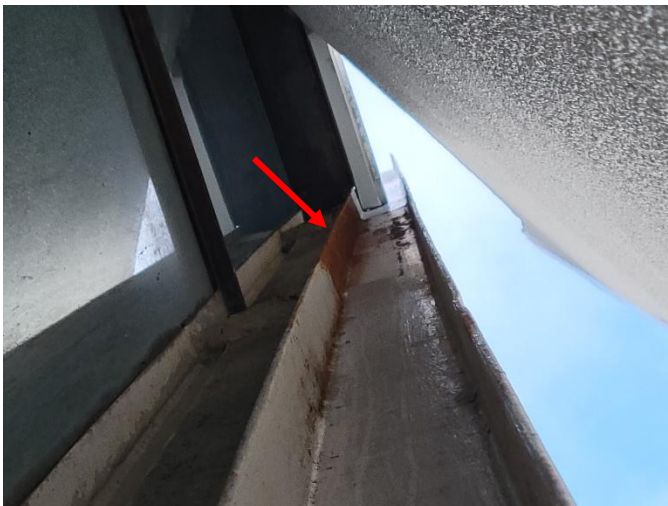
Photo 28

Several sections of the columns appear to have never been painted – likely due to accessibility issues (Photo 28). The eastern most vertical window has a narrow clearance, creating difficult working conditions. In these areas, the columns appear to have surface rust. Minimal corrosion was noted elsewhere on the columns.

Photo looking up within the eastern window opening, showing section of unpainted, rusting outer wide flange column.
Photo taken 1/18/2022

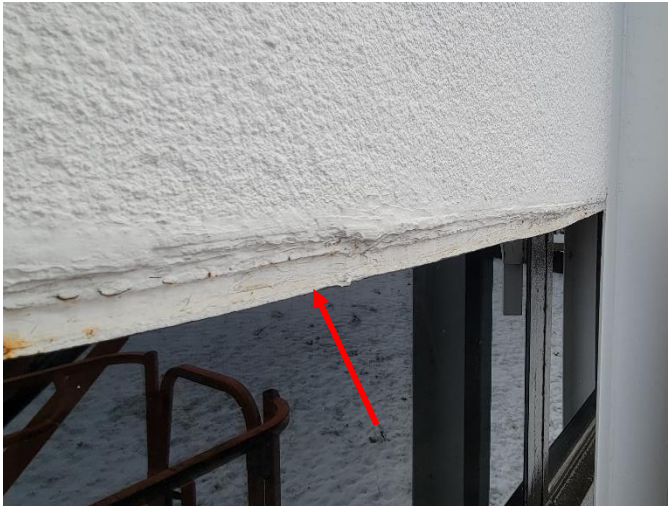
Photo 30

THP observed significant deterioration of the lower horizontal steel shelf (Photos 30 & 31). From the exterior, approximately 75% of the length of the plate shows at least moderate deformation/sagging, and approximately 50% shows signs of significant pack rust and material expansion. The plate steel undulates upwards of 1" between vertical columns. The pattern indicates severe pack rust and distress of the plate, which is constrained by the columns, but free to expand and bend at the mid-point (between the columns). As mentioned in the stucco observations above, where ZSR removed a section of stucco, the top surface of the plate can be seen to have significant rust (Photo 32). A small angle, (which appears to support the metal lath) is also significantly rusted. Several of the small steel angles that form the window frame stops have broken free from the plate, due to corrosion/expansion.

Significant deterioration of lower shelf steel plate. Swelling is indicative of pack rust.
Photo taken 2/9/2022

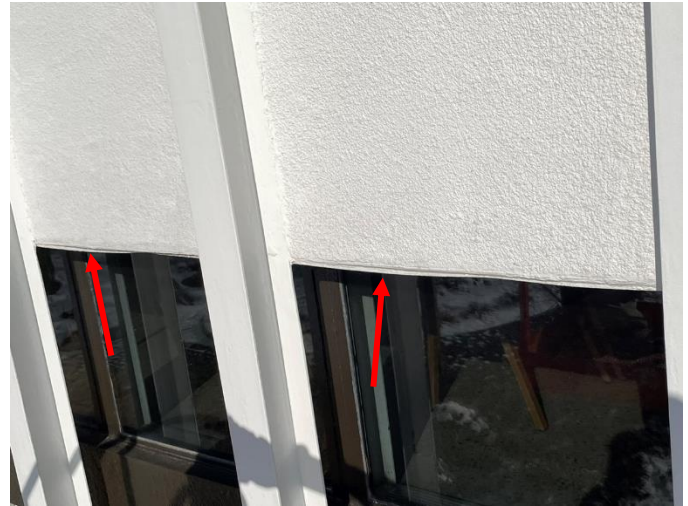
Photo 31

Undulation indicating additional deformation of lower steel shelf due to corrosion/pack rust.
Photo taken 2/9/2022

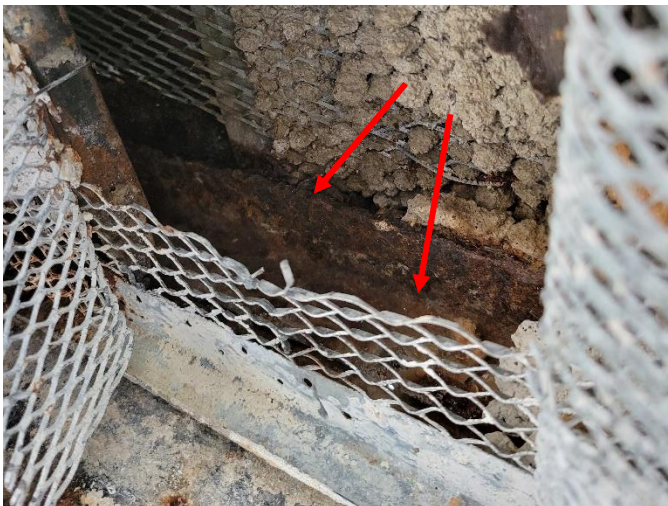
Photo 32

Significant corrosion of lower shelf, along with small, attached angle.
Photo taken 1/18/2022

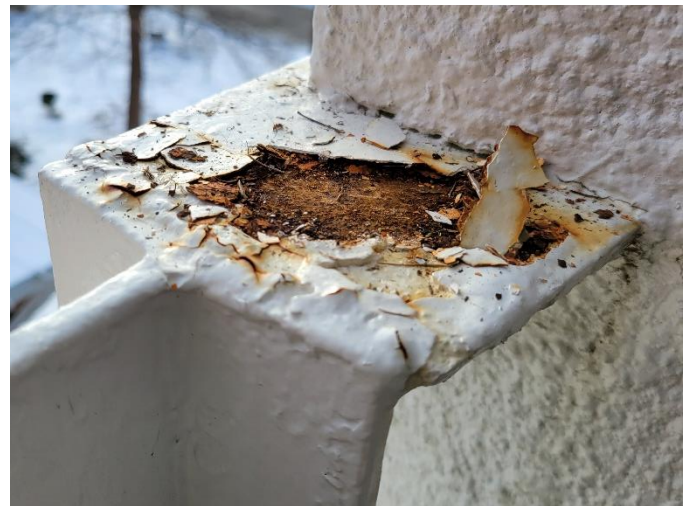
Photo 33

The trapezoidal ties that connect the inner and outer wide flange columns show signs of water damage (Photo 33). Those ties visible from the exterior have surface corrosion, and the protective paint coatings have disbonded. Ties visible from the interior also show signs of moisture damage. The stucco surrounding these ties has bubbled, and some streaking of rust is visible.

Photo of corrosion at trapezoidal steel ties.
Photo taken 1/18/2022

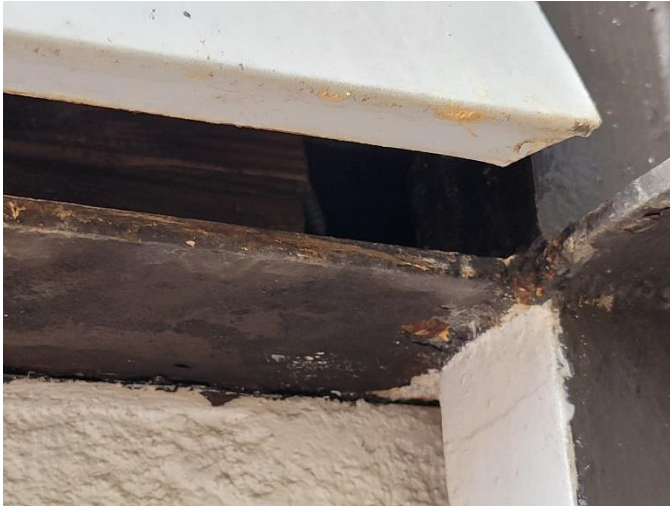
Photo 34

The upper steel shelf also exhibits some corrosion, as observed from the exterior via an aerial lift, and from the interior via binoculars (Photos 34 & 35). This corrosion appears to only be surface rust, though additional observation and assessment is recommended during the design phase.

Photo of surface rust at upper steel plate (as seen at façade end, behind bent metal cap piece).
Photo taken 1/18/2022

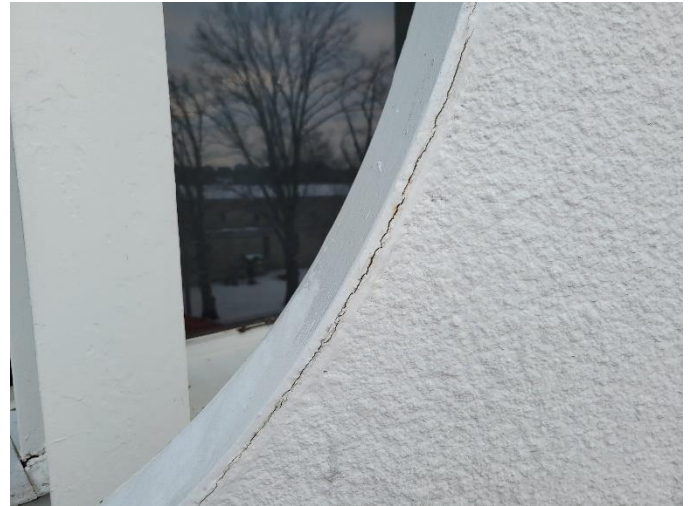
Photo 35

Deterioration of sealant between curved steel top shelf and stucco system.
Photo taken 1/18/2022

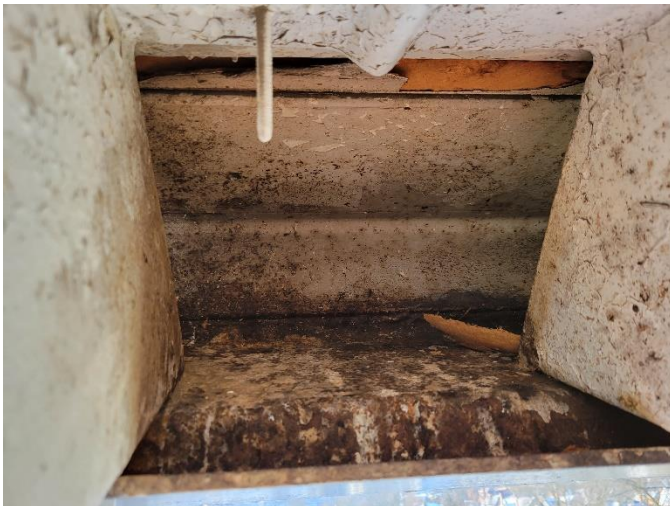
Photo 36

Photo showing corrosion and animal excrement at roof deck bearing plate (part of built-up custom roof beam).
Photo taken 1/18/2022

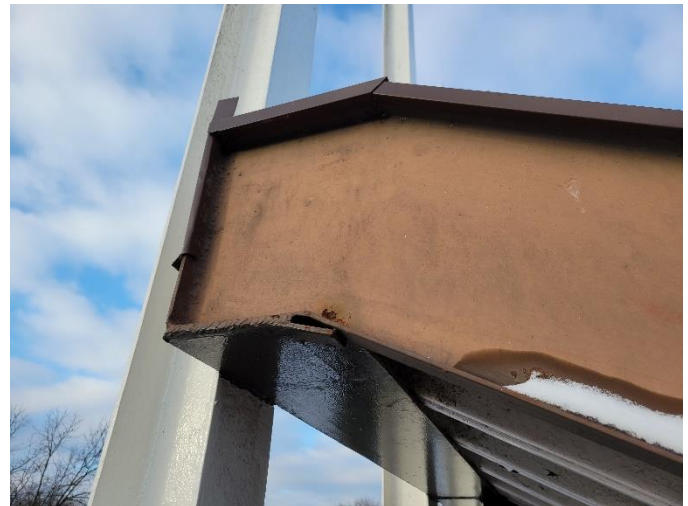
Photo 37

Photo showing minor corrosion on the roof rake beam.
Photo taken 1/18/2022

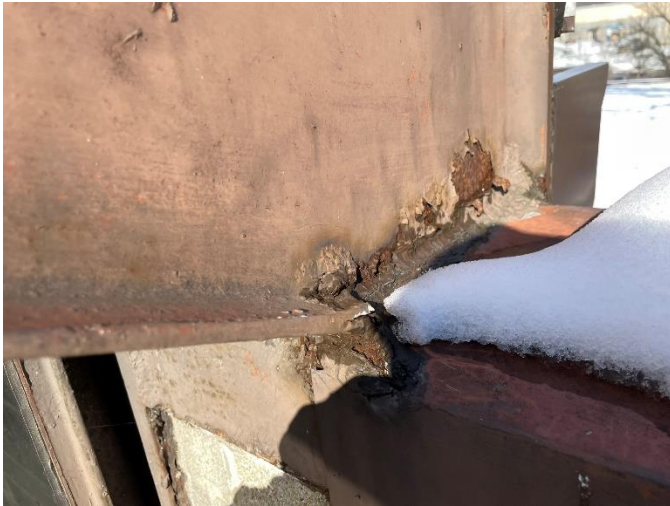
Photo 38

THP observed the exterior sections of roof structure and decking from the aerial lift on 1/18/2022. THP did not observe significant amounts of corrosion of the upper custom beam. Some surface rust was observed on the bearing portion itself, as well as some build-up of animal excrement (Photo 36). Surface rust was also observed on the outside of the rake beam (Photo 37), including more significant pitting at the lower end of the beam where it bears on the masonry buttress wall and abuts a bent metal parapet cap (Photo 38).

Photo showing corrosion at lower bearing of roof rake beam, where beam bears on the masonry buttress wall.

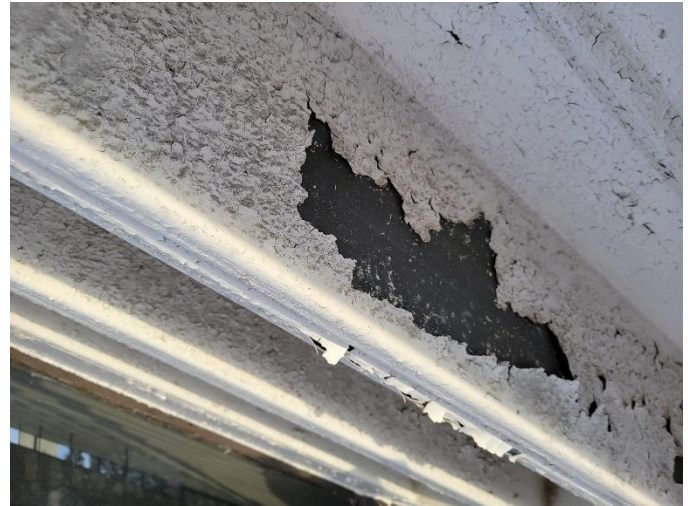
Photo 39

THP did not observe corrosion of the exposed roof deck members – however, paint was significantly disbonded from the decking (Photo 39).

Photo showing debonding of paint at exterior section of roof decking.

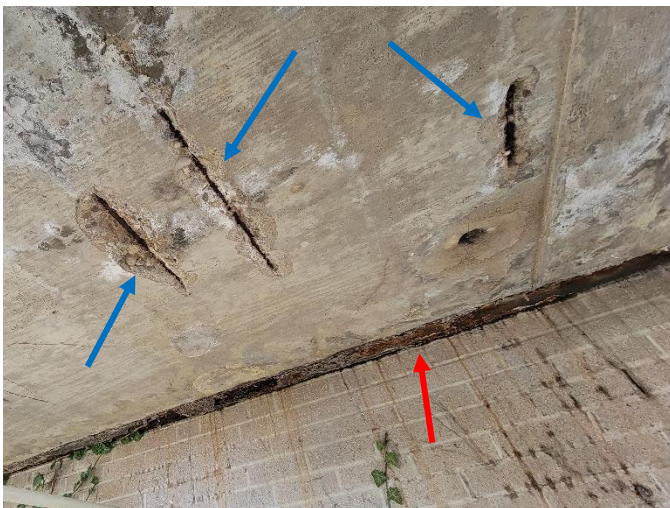
Photo 40

Photo showing underside of cantilevered landing slab, with corroded support angle (red arrow) and spalling concrete (blue arrows).

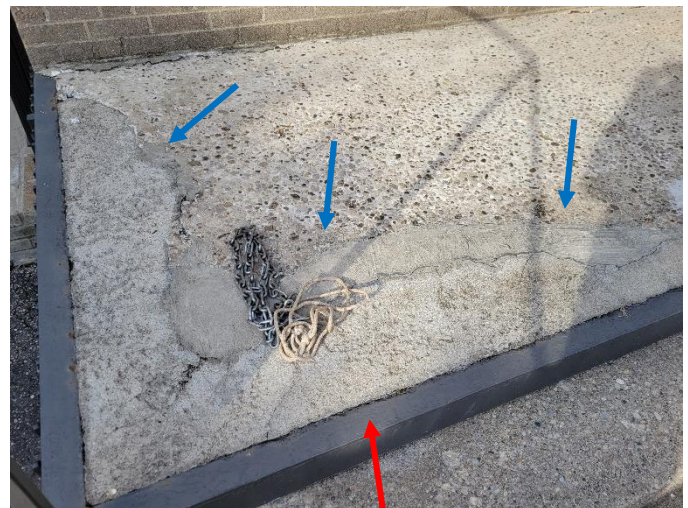
Photo 41

On either side of the sanctuary, flanking the south façade, are small sections of concrete slab that form the door landings. The outer edges of these landings are cantilevered, and the inner edges bear on ledge angles, which are in turn mounted to the masonry buttress walls. At both side of the sanctuary, the angles are significantly deteriorated, and some spalling concrete and corroded rebar was present on the underside of the slab (Photo 40). Surface corrosion is present at the built-up steel that forms the outer-edges of the slabs. Both concrete landings show diagonal cracks across the outer corner. Chain-dragging of the slab indicated that approximately 25% of the concrete has delaminated (Photo 41).

Photo of surface corrosion on cantilevered steel (red arrow) and cracked/delaminated concrete along outside edges of slab.

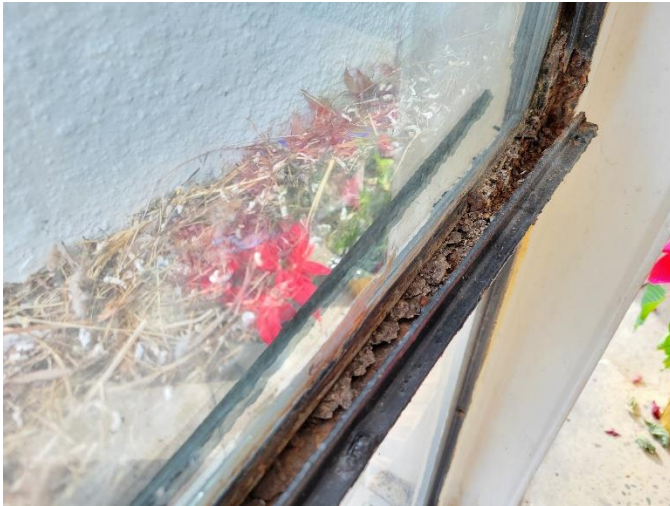
Photo 42

- At the lower steel shelf, pack rust and corrosion of the plate steel has caused several angle glazing stops to either corrode or break free (Photo 42).

Photo showing loose angle glazing stop at lower shelf.

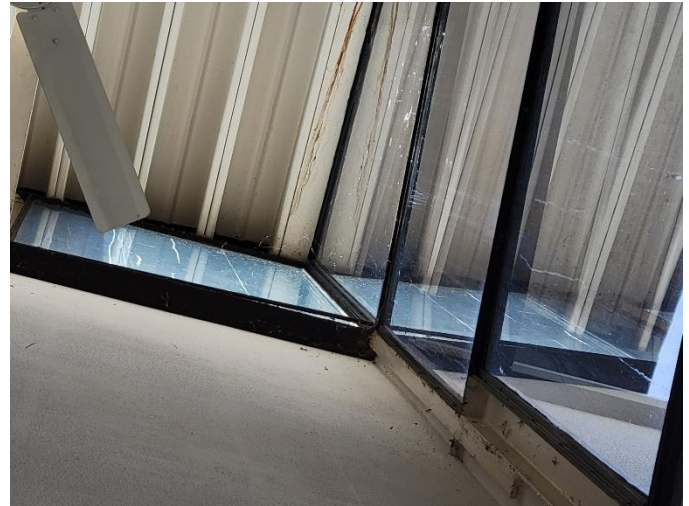
Photo 43

- Similar corrosion and deterioration of the stops of the clerestory windows was visible via binoculars (Photo 43).
- The exterior sealant between the outer frame and the insulated glazing has stiffened and disbonded in some locations.

Photo showing loose angle glazing stop at upper shelf.

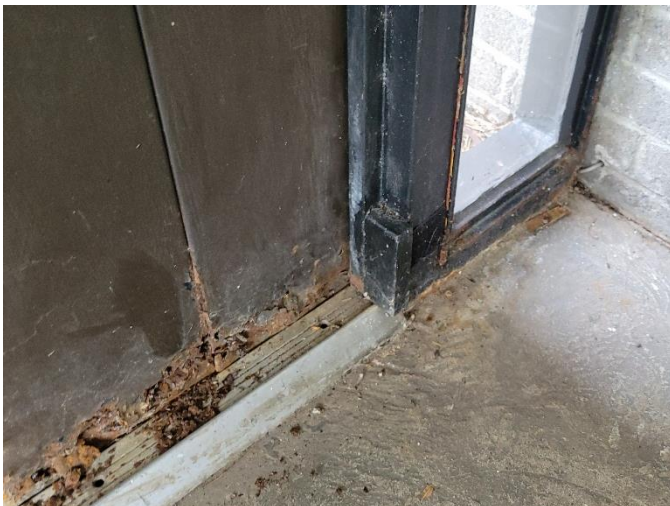
Photo 44

- The steel window system around the flanking sanctuary entry doors is rusted. The bottoms of the doors themselves are significantly rusted (Photo 44).

Photo showing rust at glazing system around entry door, and corrosion of door itself.

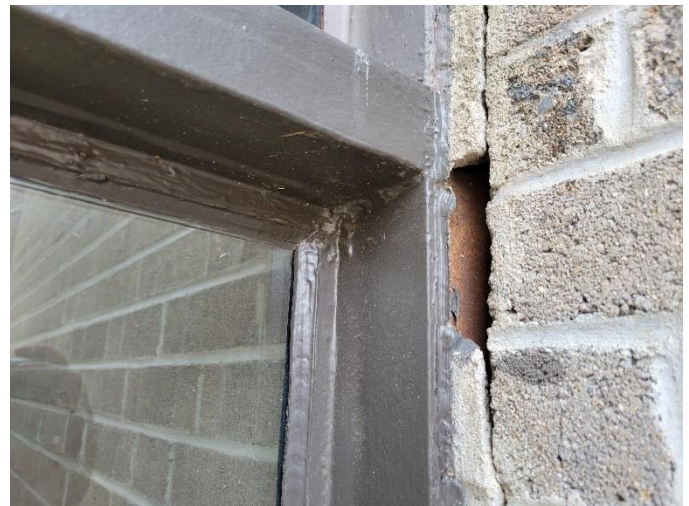
Photo 45

- The support angle set in the masonry buttress wall (that anchors the window system) is exposed in some locations. The visible sections of steel have some surface rust. Additional cracks in the mortar above and below are visible (Photo 45).

Photo showing surface rust at window anchor angle, as well as deteriorated sealant around glazing.

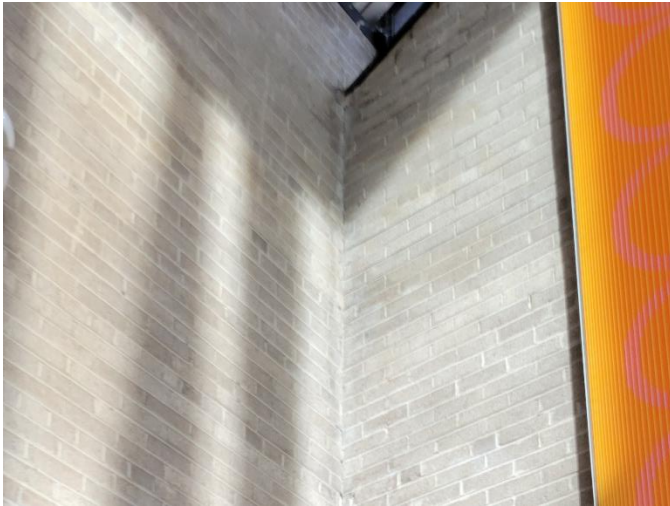
Photo 46

Photo showing inside corner where the north masonry wall meets the east wall. Mortar at this joint is loose.

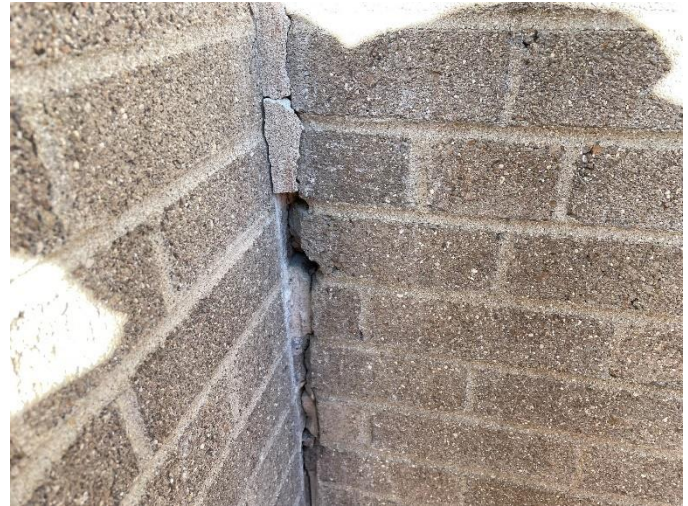
Photo 47

Photo showing outside corner where north masonry wall meets the east wall. Mortar at this joint is loose or missing.

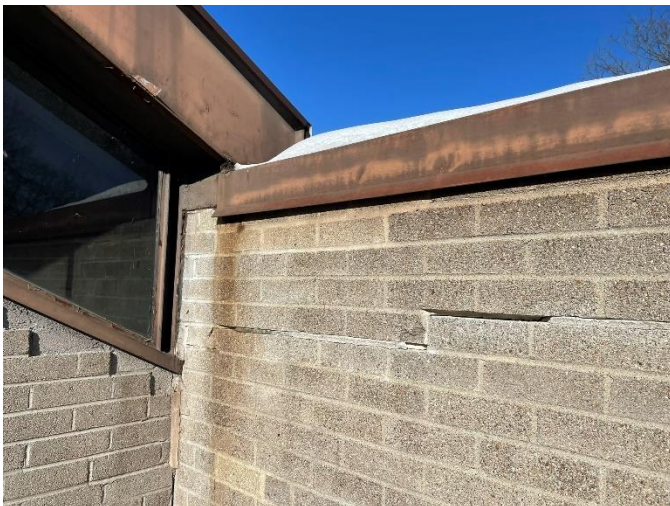
Photo 48

Photo showing corroded bent metal flashing cap, and loose bed joints at masonry buttress wall.

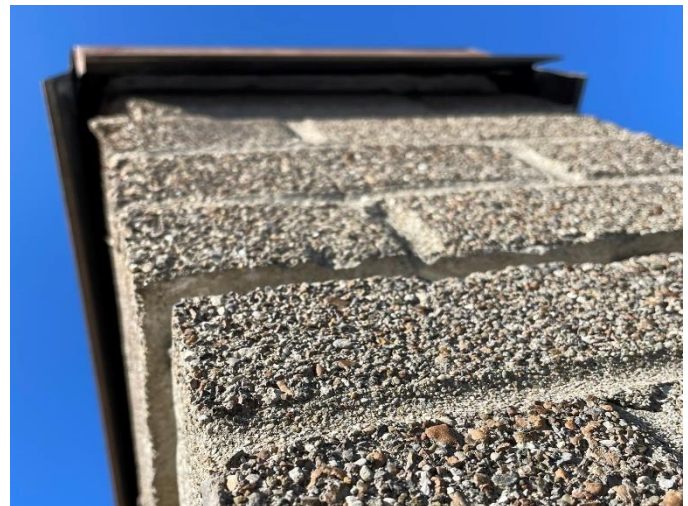
Photo 49

Photo showing shifted section of masonry wall.

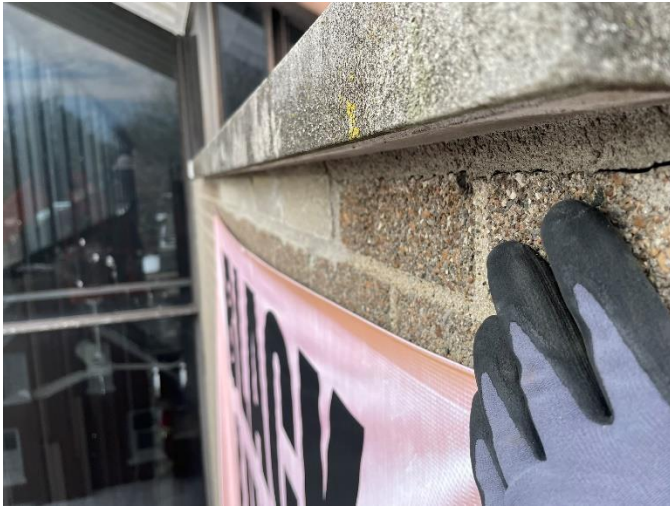
Photo 50

- Where the east masonry wall turns to form an exterior buttress, the cast stone cap is loose, and is not anchored to the wall below (Photo 50). Some evidence of prior repair can be seen, as evidenced by different color mortar joints and infill brick (Photo 51).

Photo showing disbonded mortar and loose wall cap at east wall buttress.

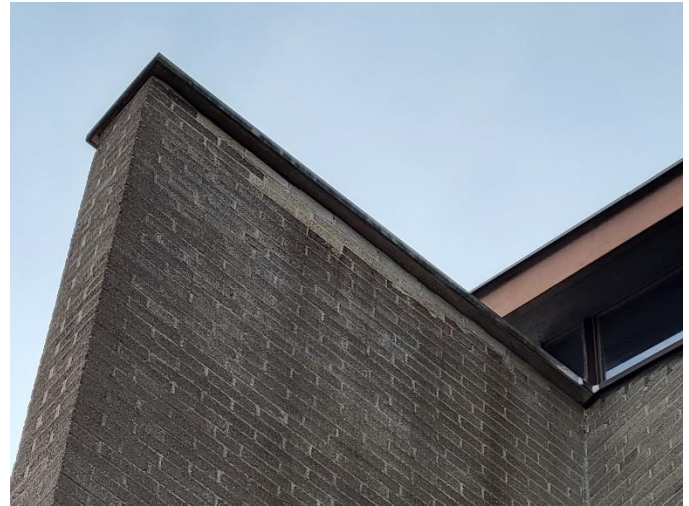
Photo 51

Photo showing evidence of past masonry repairs (included unmatched brick and mortar) at back of east wall buttress.
