# **SITE AND FACILITY MASTER PLAN 2018**

## **ST JOHN'S UNITARIAN UNIVERSALIST CHURCH**

*Prepared by  
Childress & Cunningham Architects  
and BTH Construction Delivery*

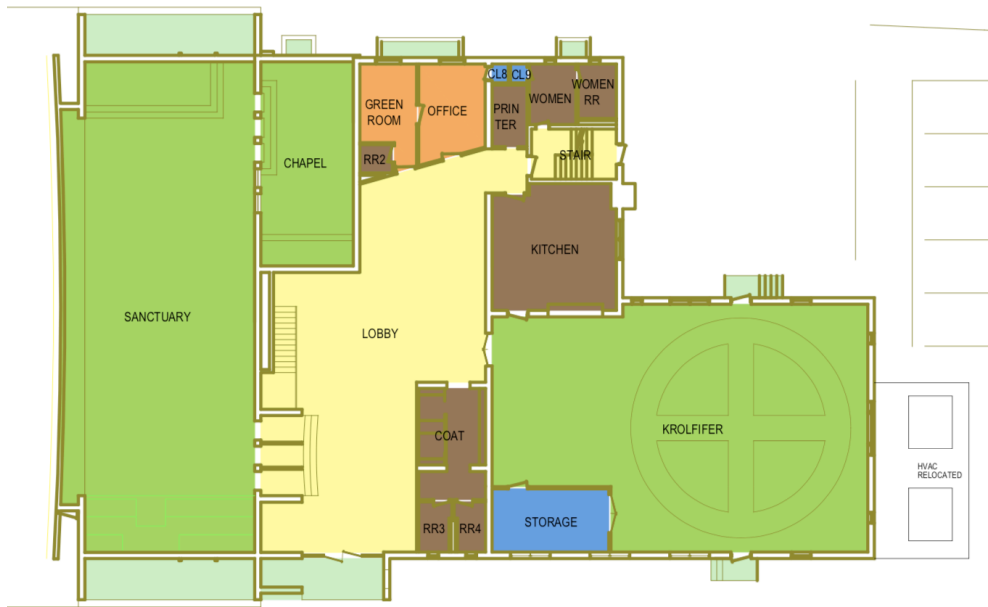
Figure 18: Option B, Phase 1

Option **B** phase 1 is only the mechanical and structural repair and improvements. Option B bundles the lobby, kitchen, and toilet room renovation with the exterior improvements in phase 2. This will allow the fundraising process a longer time to proceed, but could incur additional construction cost from inflation.

Structural Repairs In sanctuary	\$100,000
HVAC Relocation Relocating new HVAC units	\$180,000
Window Repairs In sanctuary	\$150,000

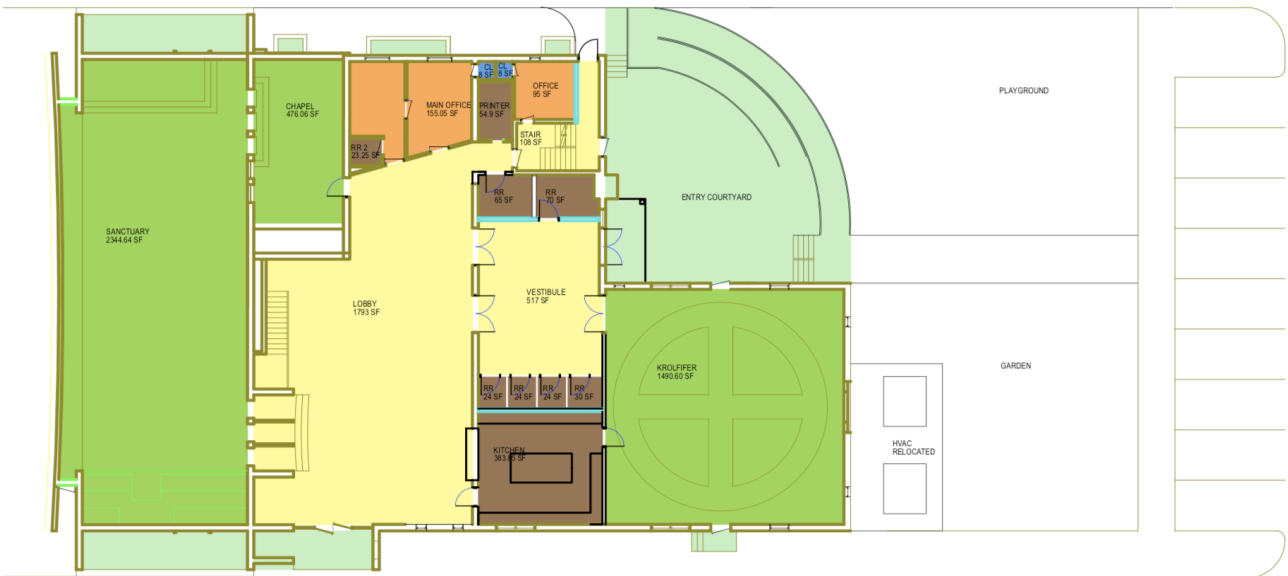
Figure 19: Option B, Phase 2

Lobby Renovation Existing Lobby renovation and expansion	\$250,000
Kitchen/Toilet room Renovation Relocate kitchen, new toilet rooms	\$400,000
Parking Lot, Garden & Playground Reconfiguration Repave lot, relocate existing playground equip	\$115,000
Exterior Plaza	\$250,000
Inflation (5% annual)	\$ 50,750
