THP Limited

St. John's Unitarian Universalist Façade Study

by THP Limited, Inc. • March 2, 2022 • THP 21308.00

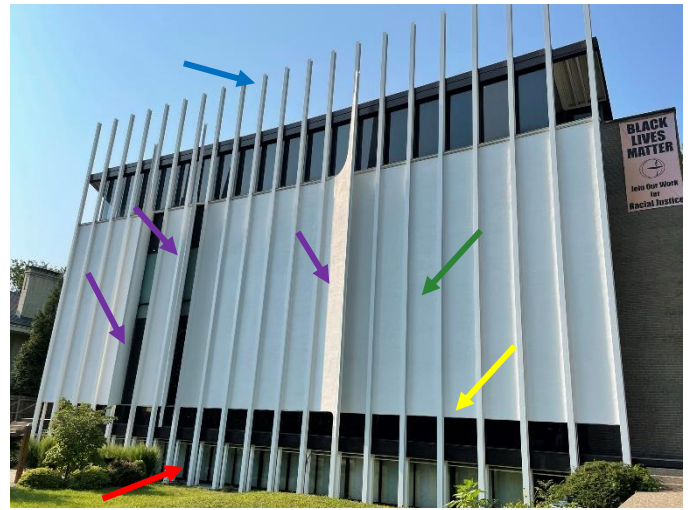
Photo 01

Photo of paired columns (red arrow), stucco cladding (green arrow), bottom steel 'shelf' (yellow arrow) and column extension (blue arrow). Note the cantilevered, curved sections of cladding at full height strip windows (purple arrows).

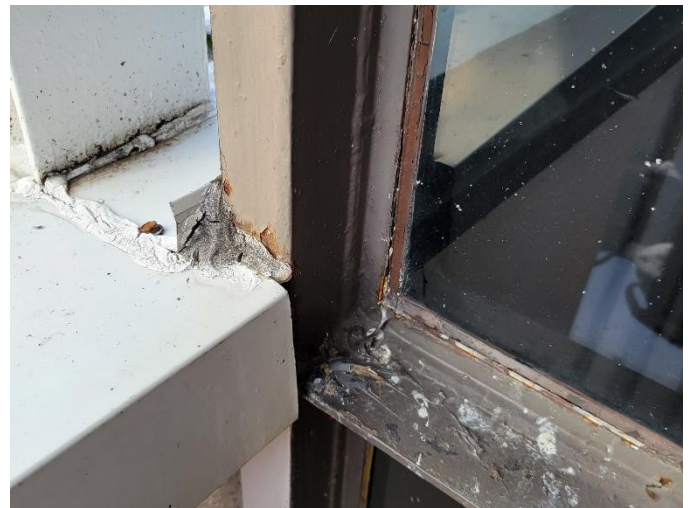
Photo 03

Photo showing bent metal flashing cap at corner of sanctuary.

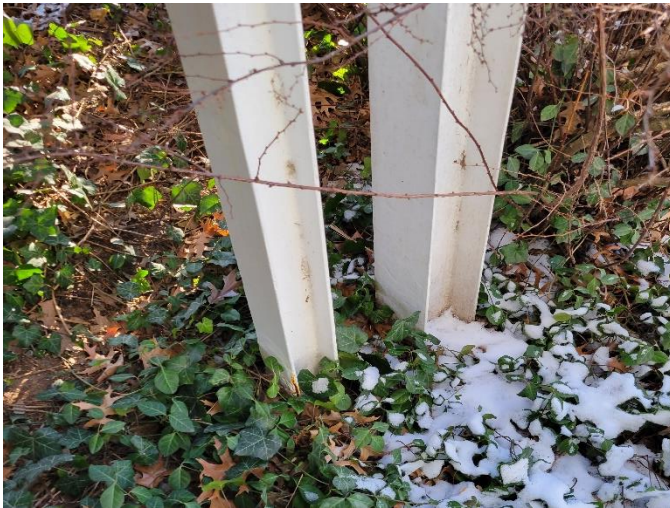
Photo 04

Photo showing paired column bearing location, with concealed concrete cap.

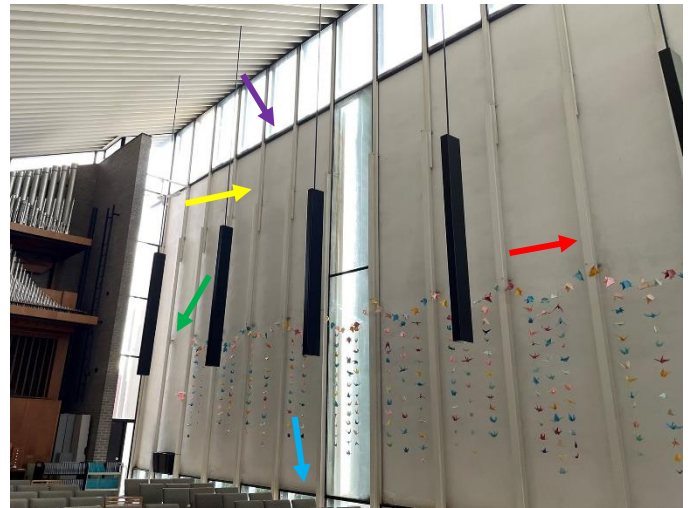
Photo 05

Interior photo showing the inner wide flange columns (red arrow), lower steel shelf (blue arrow), trapezoidal ties (green arrow), channels (yellow arrow) and upper shelf (purple arrow).

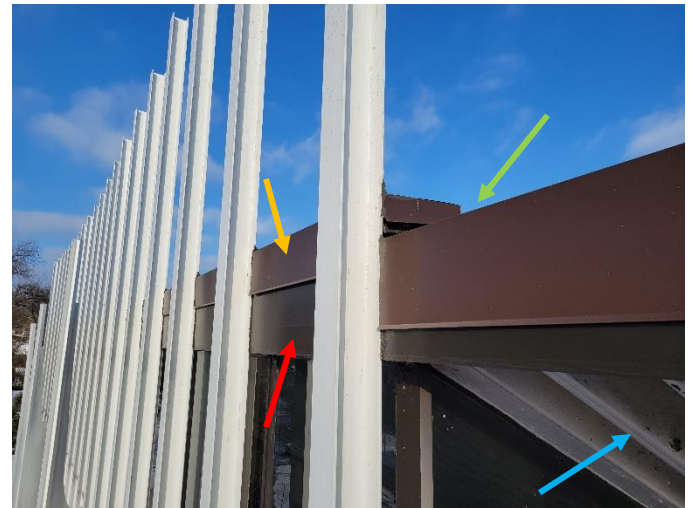
Photo 08

Photo of the south façade at the roof, showing custom beam (red arrow), covered louvers (orange arrow), roof decking (blue arrow) and metal flashing with vent strips behind (green arrow).

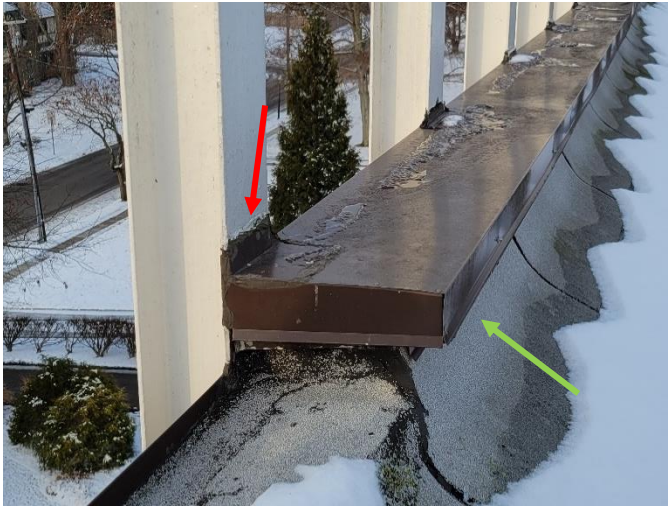
Photo 11

Photo showing upper roof flashing, including joint at wide flange columns (red arrow) and ventilation location (green arrow).

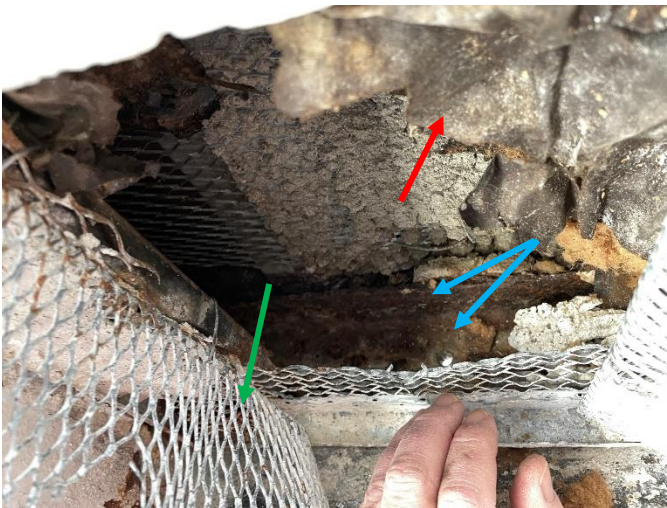
Photo 18

Photo showing interior of stucco cladding system, including insulation (red arrow), metal lathe (green arrow) and lower steel shelf with attached angle (blue arrow).

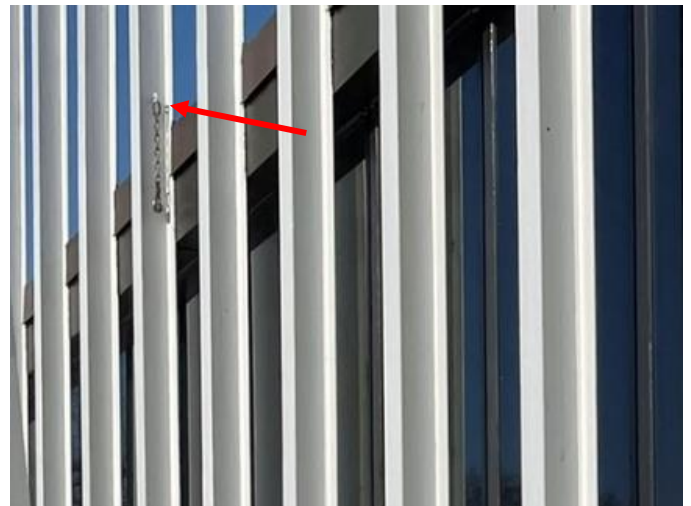
Photo 29

Photo showing miscellaneous hangers mounted to steel columns (red arrow).
Photo taken 1/18/2022
